Evaluation of Crankshaft Properties: Mechanical Testing and Microscopic Analysis

The crankshaft is a critical element of internal combustion engines, extensively utilized in automotive applications. Fatigue failure represents the most prevalent mechanism of crankshaft failure. The experimental analysis focused on investigating the properties and characteristics of the material used in manufacturing the shaft for the ARO 244 vehicle. This research aimed to comprehensively evaluate the material's performance under operational conditions by examining its chemical composition, microstructural features, and mechanical behaviour. By understanding these attributes, the study sought to assess the suitability of the material for ensuring the durability, strength, and reliability of the shaft during prolonged use. The vehicle was manufactured at Brasov, having in the moment of failure more than 400,000 kilometers. The samples were analysed from microscopic, chemical, and mechanical perspectives. From a mechanical standpoint, the samples were subjected to bending, torsion, compression and resilience.

One particular investigation focused on the failure of a diesel engine crankshaft used in A

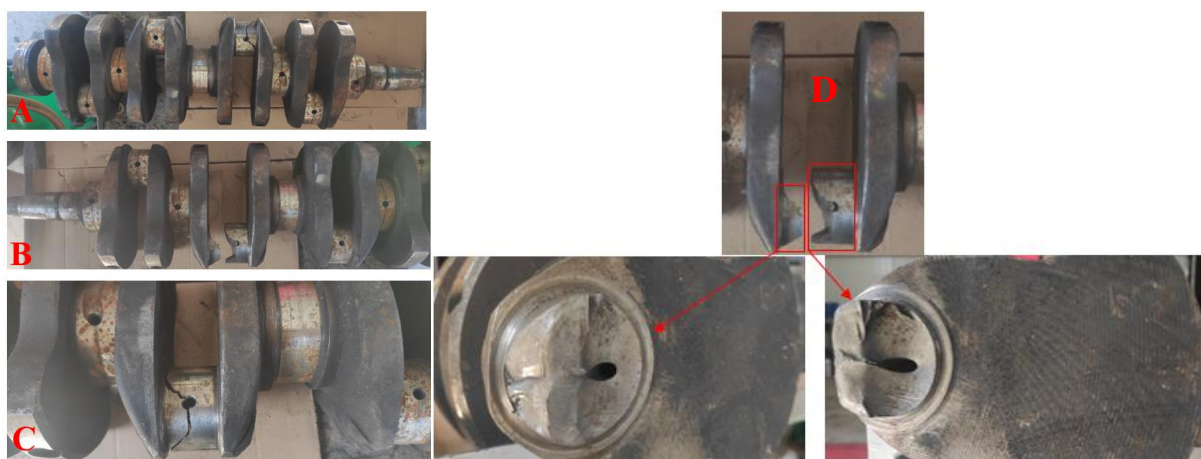
From a macroscopic point of view, it is observed that the shaft presents a fracture in the connecting rod crankpin area, around the oil lubrication hole (figure 1A).

Fig. 1. A) – Crankshaft; B) – Broken crankshaft; C) – Breakage detail
D) The appearance of the fracture surface

The fracture is ductile in nature due to the con-cup aspect it presents (figures 1B and 1C). Ductile fracture can occur when the temperature at which the part under test normally works increases. Ductile

Ductile fracture is mainly caused by tangential stresses (also called shear failure) and is preceded by large plastic deformations, the appearance of the fracture surface being matte-fibrous (figure 1D). Ductile fracture occurs trans-crystallinely and has a relatively slow propagation speed.

The experimental research of this study was based on the metallographic, chemical and mechanical characterization of a crankshaft that failed during operation. Through macroscopic analysis, it was determined that the shaft failed due to the propagation of a crack that led to its breakage in the crankpin area. This area is prone to failure during operation due to the forces acting on it: - the connecting rod attachment area from the piston: area with stresses induced by the connecting rod-crank movement, friction, etc. - the area prone to the propagation of cracks that can be induced during the machining of the lubrication holes - the area prone to breakage due to temperature changes, etc.

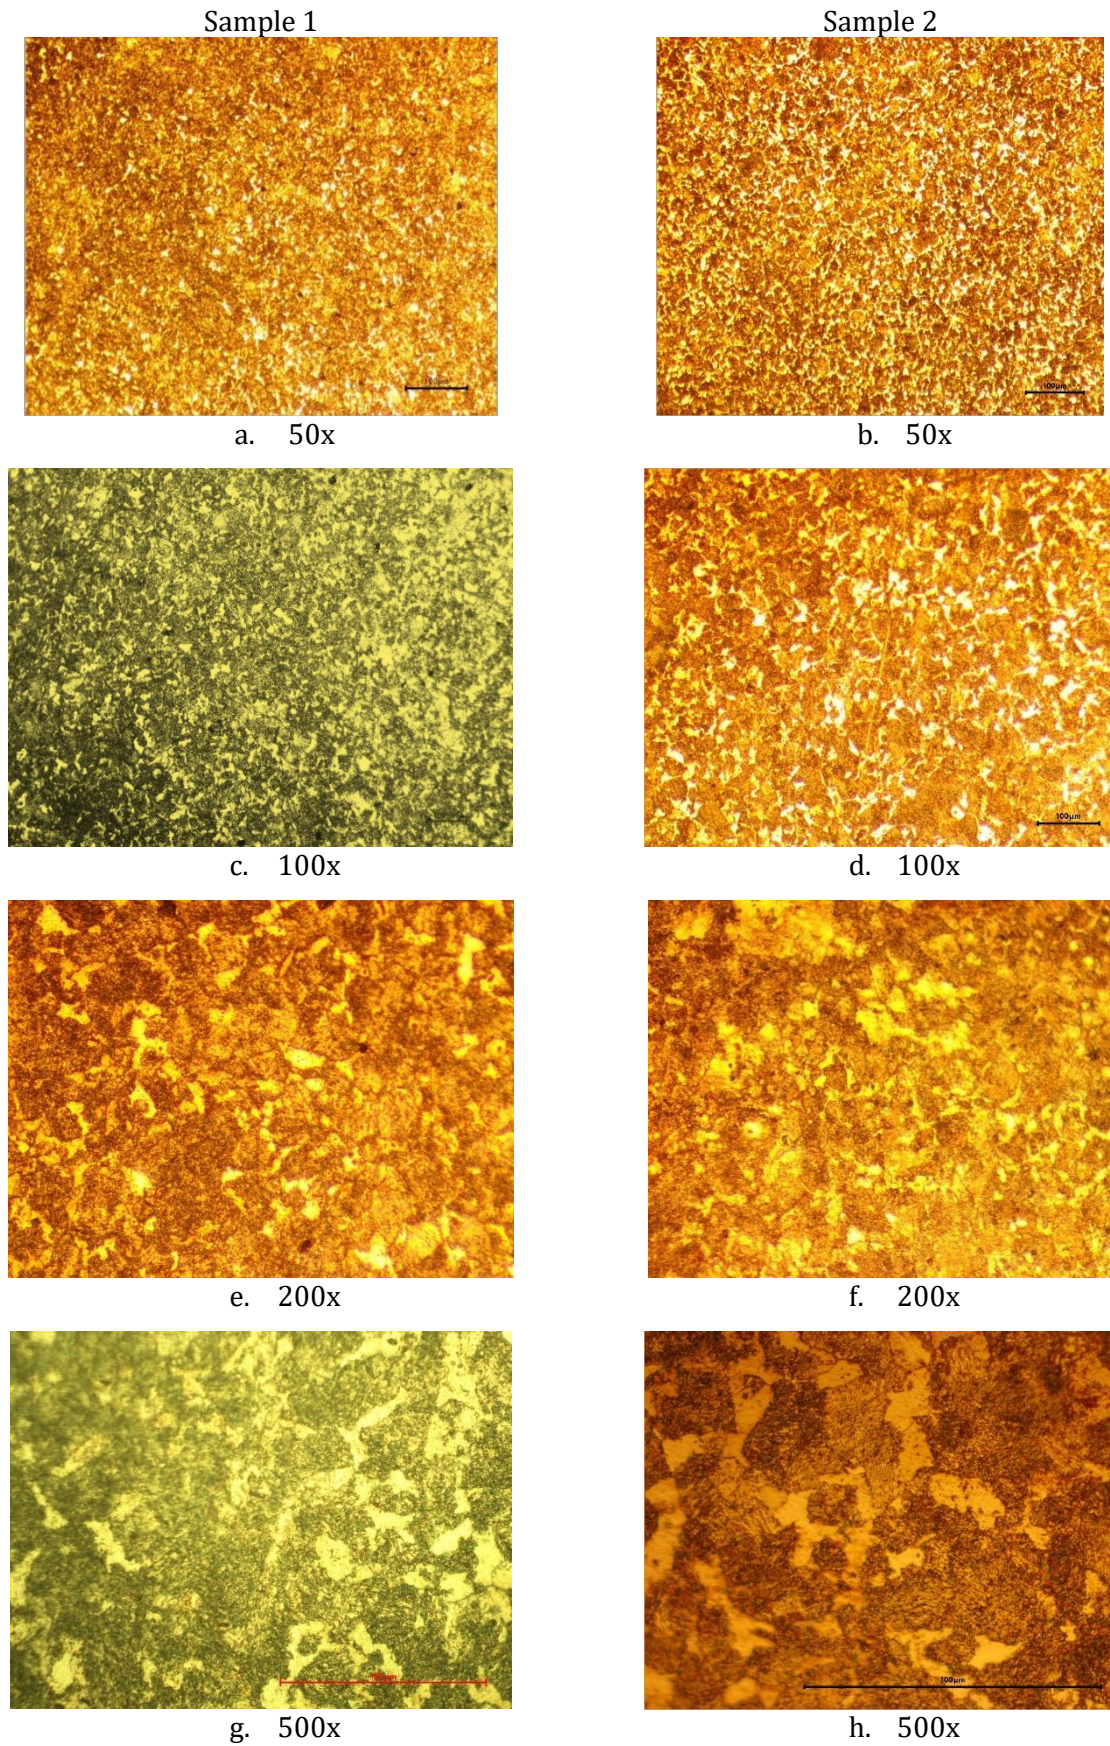
Microscopic analysis was performed on samples taken from the fracture area, to identify possible material defects that could have led to the crankshaft fracture. At low magnifications, namely 50x (figures 2a and 2b), a uniform structure is observed, formed by grains of similar shapes and sizes. The white (shiny) areas represent the uncorroded constituents, those on which the attack with 10% Nital had no effect. With increasing magnification, the structure of the material begins to be better defined, thus allowing the metallographic constituents to be differentiated.

Even at 100x magnification (figures 2c and 2d) it can be observed that the alloy is a eutectoid, namely a mechanical mixture of two (in this case) solid phases resulting from their simultaneous crystallization at constant temperature. This fact is observed more and more clearly at higher magnifications, namely, both in figures 2e and 2f, but especially in figures 2g and 2h. The eutectoid mixture is formed in this case from ferrite and cementite, thus resulting in pearlite. In its equilibrium state, pearlite is represented in the form of alternating ferrite and cementite lamellae, the appearance of the structure being comparable to a human fingerprint. From the point of view of homogeneity, it is observed that the material is homogeneous, ferrite and cementite being approximately uniformly distributed throughout the surface of both analyzed samples.

Fig. 2. Microstructures of sample at different magnifications

Microscopic analysis revealed the existence of cracks, material defects in the breakage area, an aspect that indicates that the area was prone to failure during operation. The chemical attack highlighted the structure of the material from which the crankshaft was made, namely a eutectoid mixture of ferrite and cementite, hence pearlite (human fingerprint appearance). Through chemical analysis, it was determined that the steel grade from which the crankshaft is made could be 90VMn20 according to STAS 3611-88. This is a wear-resistant tool steel, an important aspect for the proposed area I hope to use. The mechanical tests to which the samples taken from the crankshaft were subjected demonstrated that those taken from the fracture area showed a different behavior compared to the others taken from neighboring areas. The general conclusion that can be drawn from this study is that the area where the breakage occurred was an area with material defects resulting either from manufacturing or from processing the finished part.

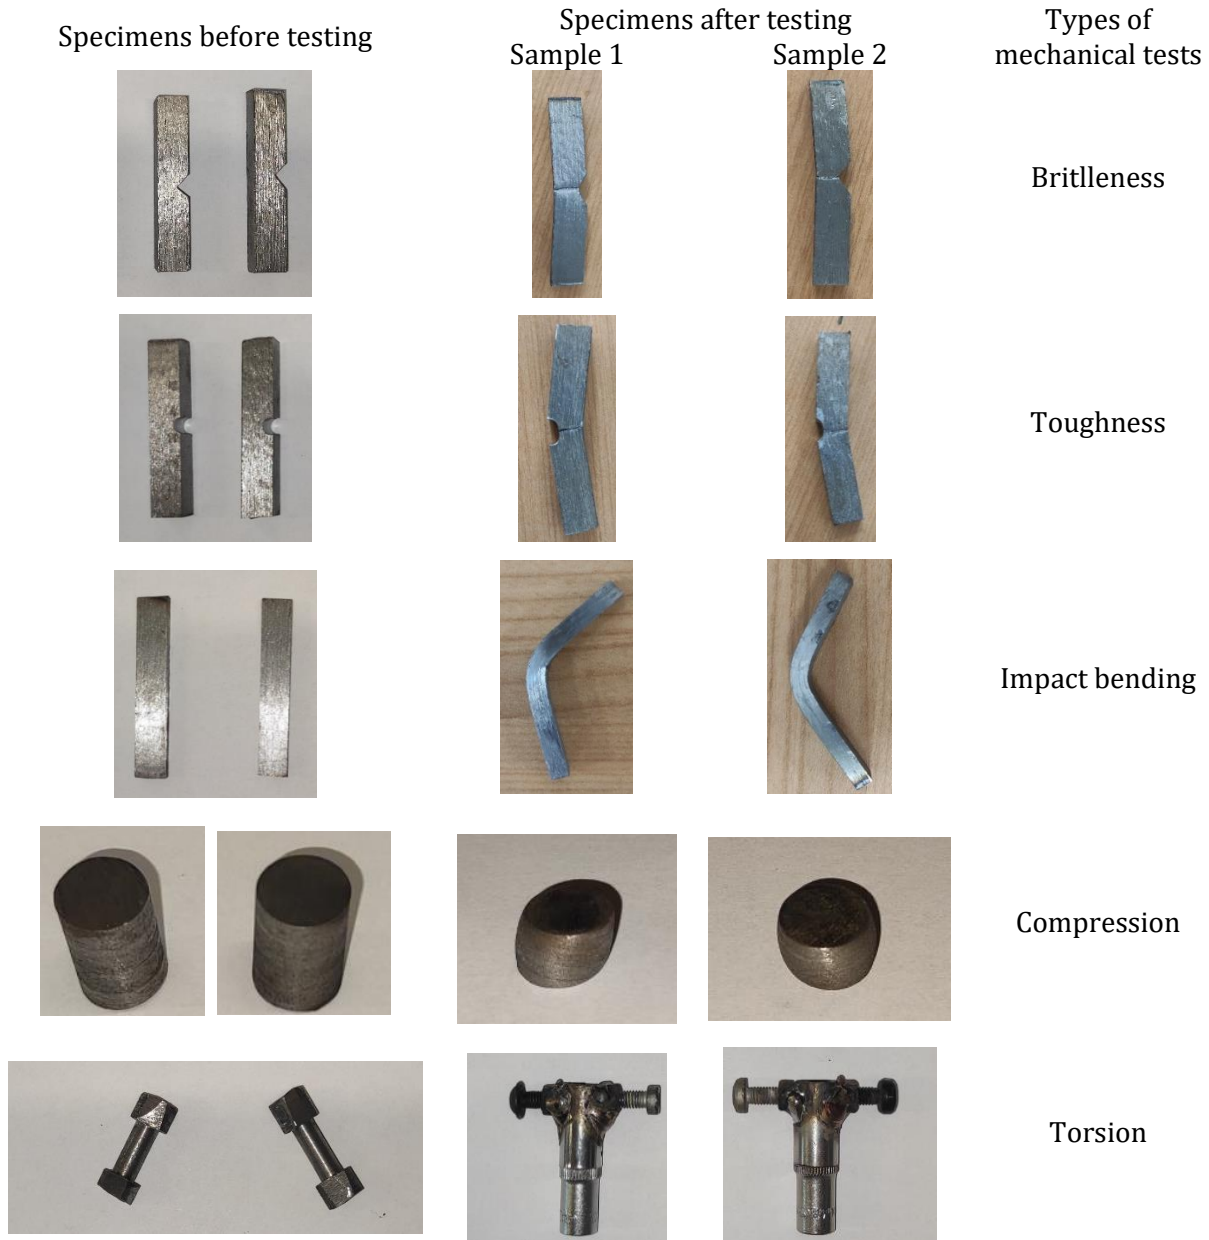
The "V" notch specimens, figure 3, used to determine the toughness of the steel from which the crankshaft was made. The material is tough when it fractures as soon as its elastic limit is reached.

Fig. 3. Samples subjected to mechanical testing

As can be seen both in the image in Figure 3 and Table 3, the sample 1 is more deformed, indicate a higher value). This may be due to the fact that the sample was taken from the same area as the one for the brittleness test. Figure shows the specimens used to determine the impact bending of the steel from which the crankshaft was made. Equation (1) was used to determine the values at which the samples bent, the values being presented in Table 4.

In figure 3 it can be seen even the samples that were subjected to the mechanical compression test. It can be noticed that they did not yield under the action of the applied force, but instead they underwent changes in terms of their shape, both presenting a barrel-shaped appearance. As can be seen from the graph presented in figure 4, regarding sample 1, it reaches the yield load at a value of 78.86 kN and sample 2 at a value of 68.22 kN.

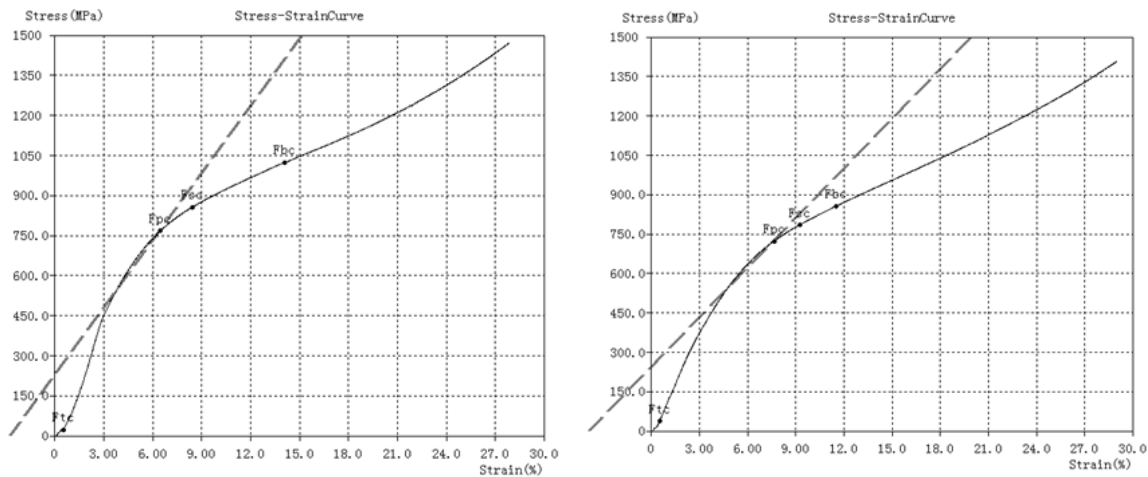
Fig. 4. Graphs of mechanical compression tests

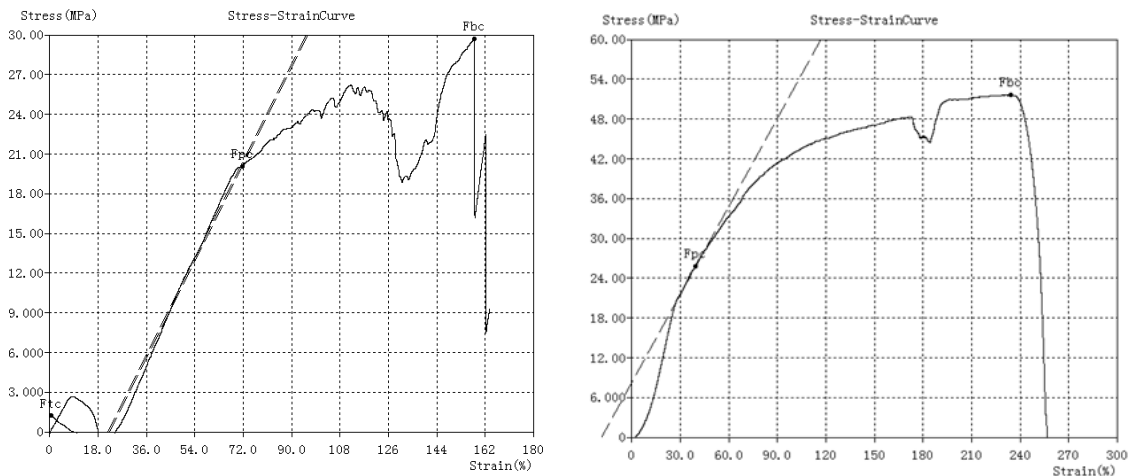
Fig. 5. Results of mechanical torsion tests

The graph shown in figure 5 shows the torsion regime of specimen number one. In the case of this specimen, the tension mechanism (suffa) of the torsion machine failed due to the resistance opposed by the sample during the stress. The conclusion of this fact can be that the material presented a good torsion resistance.
