13th INTERNATIONAL CONFERENCE
"STANDARDIZATION, PROTOTYPES AND QUALITY:
A MEANS OF BALKAN COUNTRIES' COLLABORATION"

The Architectural Accessibility Standards within the Scope of "The Regulations on the Accessibility Monitoring and Auditing" Enforced in Turkey: Case of Yalova Government Building

2. Implementation of the Accessibility Standards in Example of Government Building Designed for the Province of Yalova

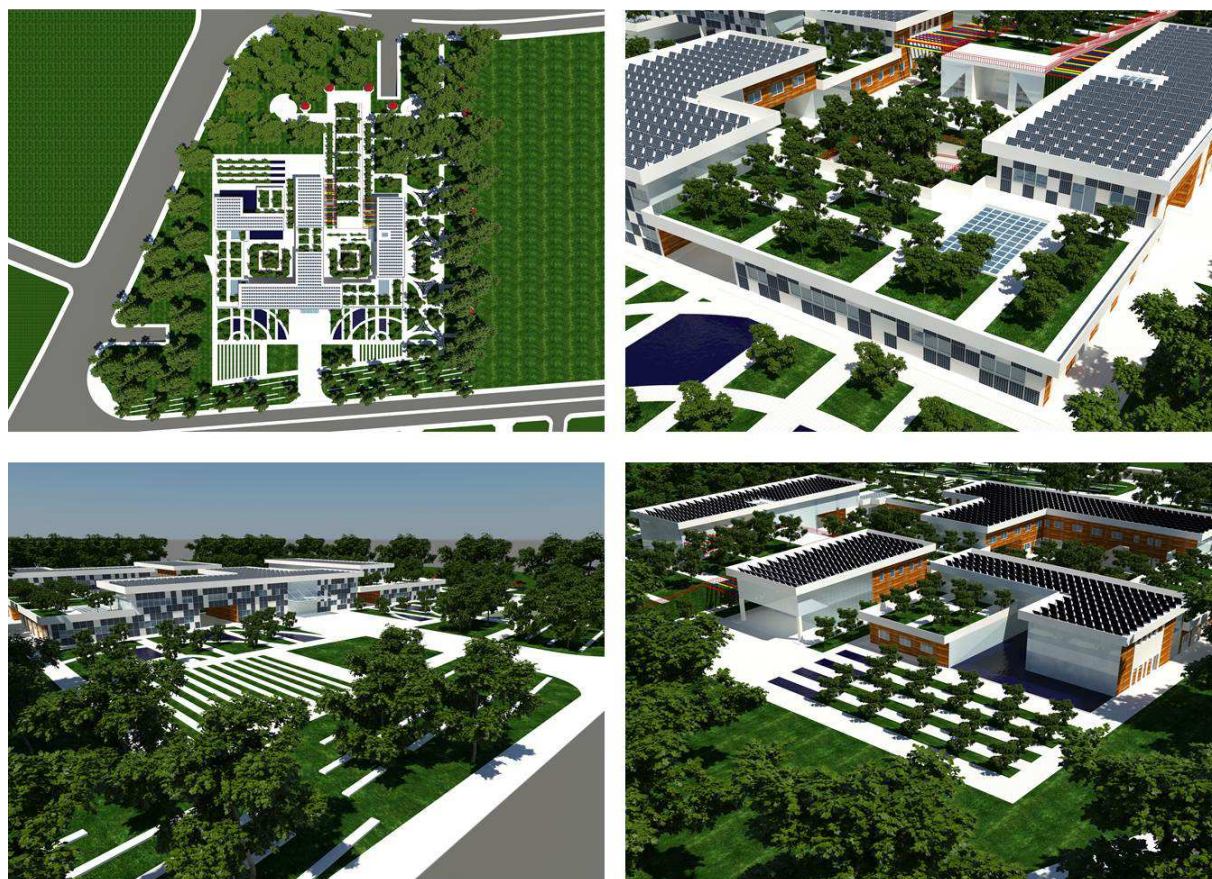
The building having a closed construction site of approximately 12,000 m² is composed of separate masses connected with each other by means of courtyards and terrace roofs. The building designed also in compliance with the sustainability standards consists of basement, ground floor, and 1st floor. As the project was in the stage of design yet, the disabled people were considered and the suitable design principles were developed. For this, the elevation of entire building was generally kept low and horizontal design was adopted instead of a vertical distribution (Figure 1). The situation of the disabled citizens was considered for each of the different blocks emerging.

Fig. 1. Modelling study of the project of Yalova government building

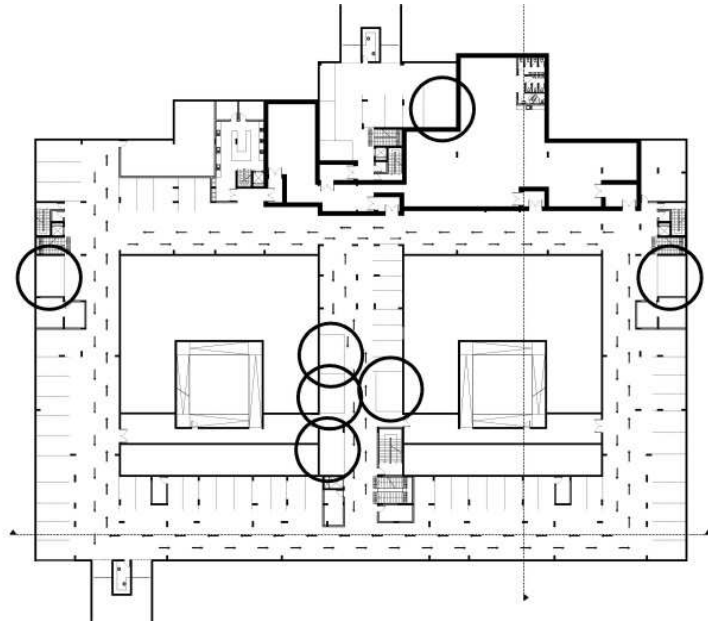
In the project, all the parking lots were designed as closed and located on the basement floor. 7 of 72 parking spaces in total were arranged for the disabled people (Figure 2). This ratio which must be 5% according to the regulations was kept higher since the building of project was composed of different masses. The parking lots in sizes of 4,00×6,00 m were positioned as close as possible to the stairs core and the signs were used for making necessary directions.

Fig. 2. Parking spaces for the disabled in closed parking lot

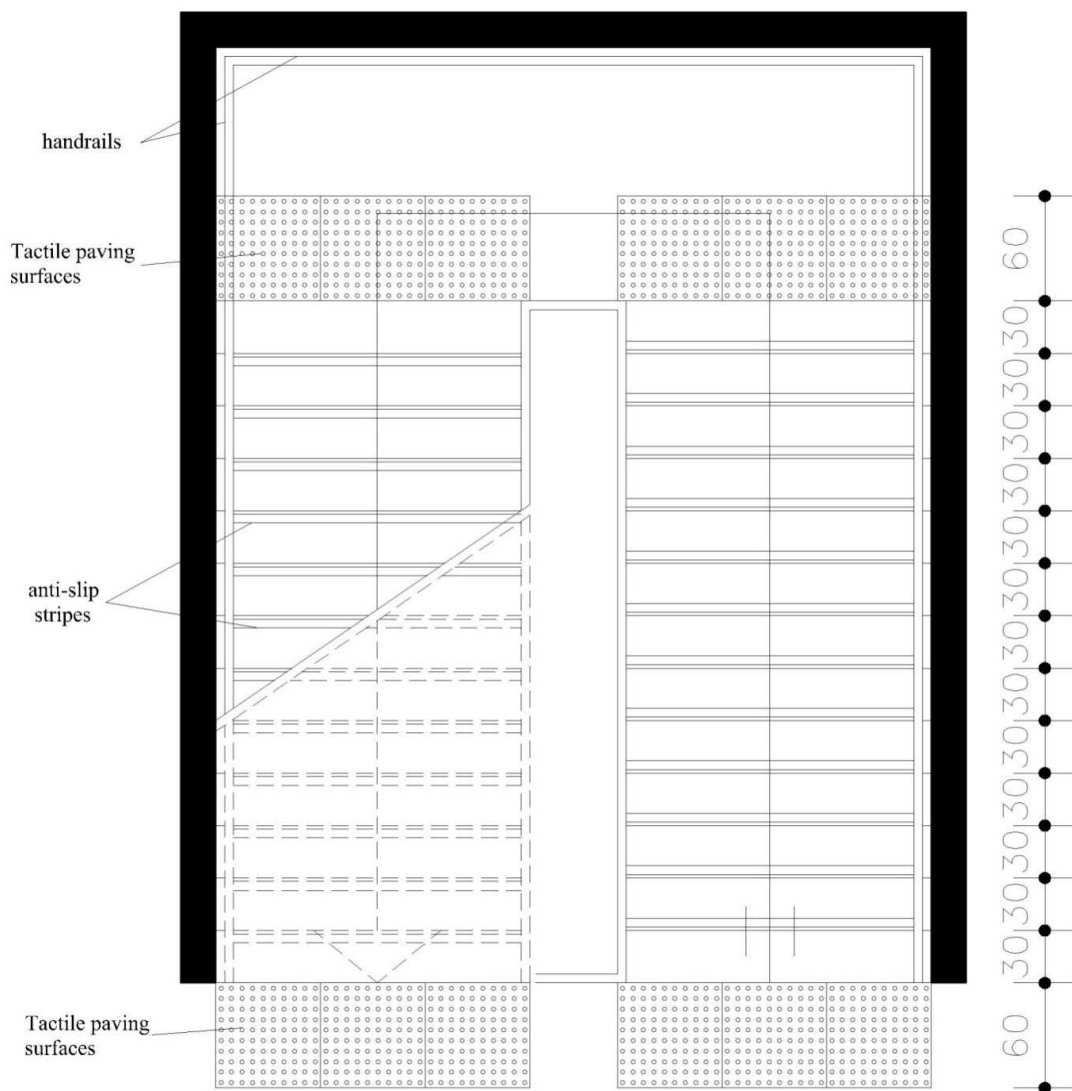
The steps and stairs in the entire building were redesigned according to the following standards (Figure 3):

Fig. 3. Example of internal stairs from the project

- The coloured marbles were used and turned into anti-slip by applying anti-slip materials since the steps must be made of flat, fixed, durable, and wet-dry anti-slip materials.

- The width of steps is 30 cm in entire project since it is supposed to be 28-32 cm and at least 30 cm in internal and external stairs, respectively. The heights of steps in internal stairs and external stairs were 16.66 cm and 10 cm, respectively, since the maximum height of steps in the internal stairs and external stairs are supposed to be 15-18 cm and 15 cm, respectively.

- The width and height of all steps in the stairs were kept same; the closed stair risers were constructed and the edges of step were not protruding. Moreover, the anti-slip stripes having a width of 5 cm which are different coloured and can be easily sensed were used without ridge in the edges of step.

- The railing and handrails were fitted near the stairs and stair landings. Tactile paving surfaces in depth of 60 cm were made 30 cm before the stairs and 30 cm beyond the end of stairs.

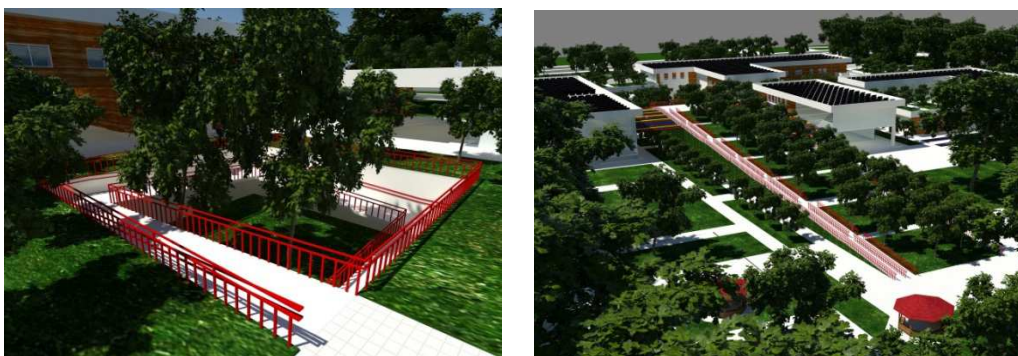
Top of conference hall in the project was arranged as a ramp, so it is aimed that the users can reach the observation deck by walking (Figure 4). Moreover, the ramp-type exits which enable the users coming from the parking lot on the basement floor to go out the courtyard directly were formed. These parts (Figure 5) were constructed according to the accessibility standards required for the ramps and can be summarised as follows:

- Since the height covered with the ramp is more than 100 cm, the problem has been solved in a manner that slopes of the ramp will be 6%. The width of ramp which must be at least 100 cm according to the regulations was 2.00 m for the exits of courtyard and 125 cm for the ramp of observation deck (2 pieces).
- Since the direction of the ramps of the courtyard changes in the stairs landing, the required manoeuvring spaces which must be 150x150 cm were designed as 200x200 cm. The railings and handrails were constructed along both sides of the ramps.
- Since the length of ramp was more than 9 m, the resting areas of 150x150cm were formed in every 9 m. The problem of the resting area was solved with 2 resting areas of 3.00 m in this section, since the length of ramp of observation deck exceeds 30 m and it is required to form the resting areas of 2.50 m in every 30 m.

Fig. 5. Modelling of the ramp to the courtyard (left) and ramp to the observation deck (right)

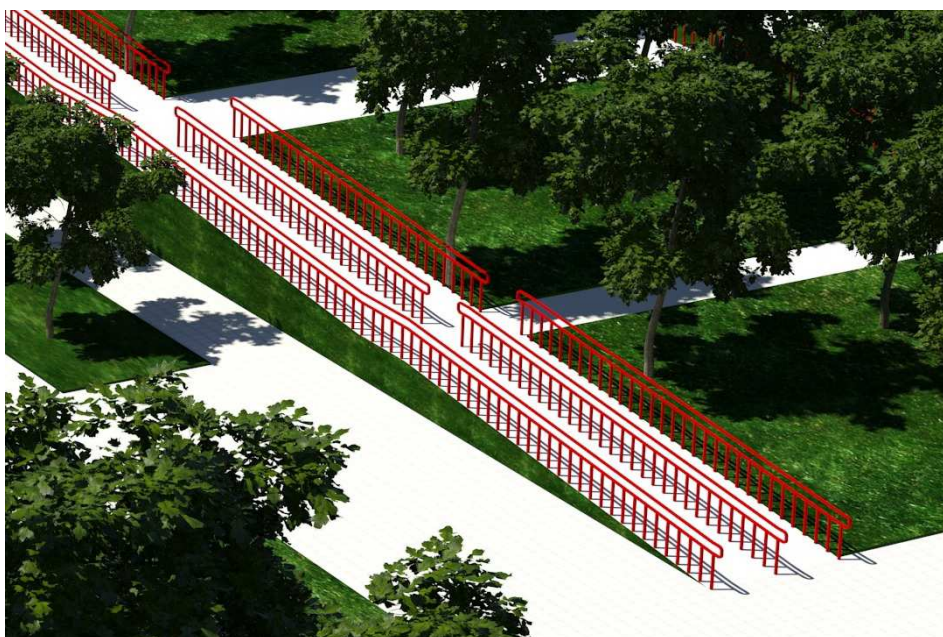
The railings and handrails were constructed for all the stairs and the ramps exceeding a height of 15 cm in the project (Figure 6). The following standards were followed for them.

- The handrail was 90 cm above the flooring. There was a second handrail in the height of 70 cm. Moreover, the edges of the handrail were rounded.
- The diameter of handrails was selected as 40 mm as it is required to be between 32 and 40 mm. The colours of the railing and handrails were selected contrary to the environment so that they can be easily sensed. The handrails start 30 cm before the beginning of ramps and stairs and end 30 cm beyond the end of stairs.

Fig. 6. Modelling of railings and handrails

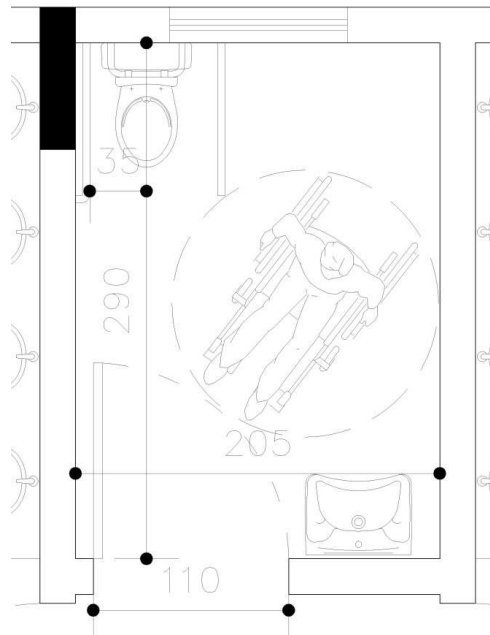
A toilet for the disabled is present for toilet groups in all separate blocks inside the building. Therefore, there are 13 toilets for the disabled in total. The following standards were complied while constructing these toilets (Figure 7):

- The sizes of toilets and layout of furnishing were arranged so as to be suitable for the manoeuvring space with a diameter of 150 cm. The width of doors is supposed to be at least 90 cm, however, it was designed to be 110 cm and the matt ceramic was preferred as the floor covering is required to be flat, fixed, durable, and anti-slip material. Moreover, necessary direction signs regarding the toilets for the disabled were provided inside the building.

- The sinks suitable for being used by the disabled people were used. These sinks would be at least 75 cm until the lower part and max 86 cm until the upper part in height, and have a knee clearance with at least 20.5 cm depth. The soap dispensers would be 80-110 cm above the ground and the height of water closets would be between 43 and 48 cm.

- The taps and siphons can be used with one hand without any necessity for grasping and the height of button of siphon would be maximum 112 cm above the ground. The toilet paper holder and bidet nozzle would be 43-48 cm above the ground and be in an easily accessible point. The bottom edge of mirrors would be maximum 90 cm above the ground and be placed with oblique angle.

- The grab bars were installed on both sides of the water closet. The one adjacent to the wall side is fixed, while the other one is movable (a folding type). The grab bar on the wall side would be 80-95 cm above the ground and the distance between the bar and wall would be 4 cm. The distance between mid-point of water closet and the bar would be 30-35 cm. Emergency call apparatus which can be operated by pulling the cord was positioned in a manner that the disabled person can reach at the seated position and on the floor when the disabled has fallen.

Fig. 7. An example of toilet for the disabled from the project

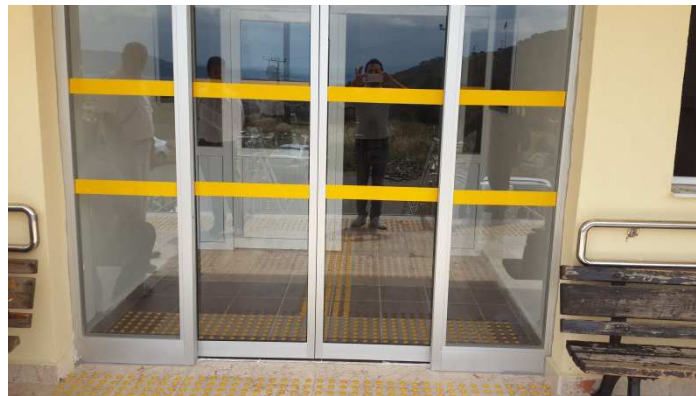
The clear opening width of all doors was allowed to be at least 90 cm and no threshold was available. Yellow warning tapes were applied on the glass entrance doors of the building (first level was 130-140 cm above the ground and the second level was 90-100 cm above the ground, and a width of at least 7.5 cm) (Figure 8).

Fig. 8. An example of applying warning tapes on glass surfaces, Yalova Armutlu state hospital (Archive of Sahin Durak, 2016)

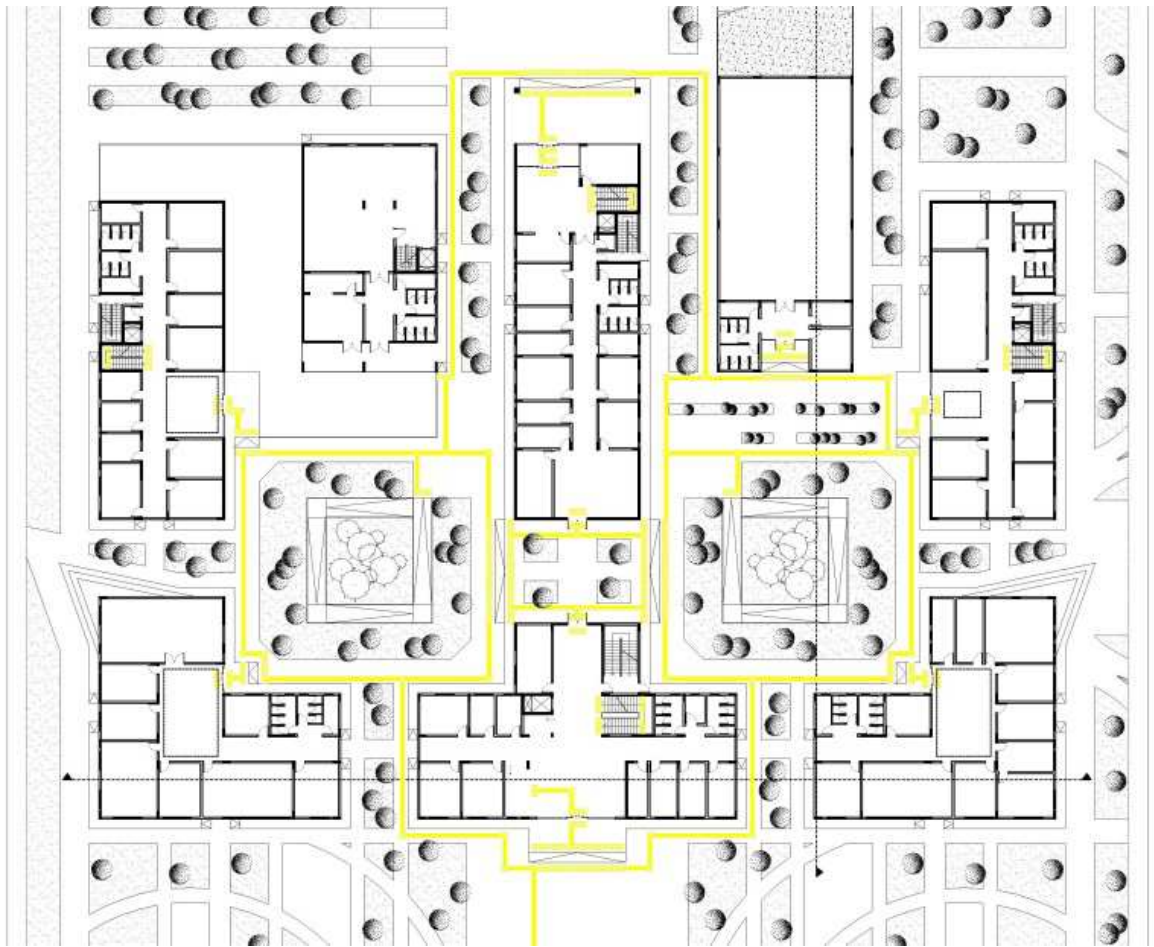
In our project composed of different blocks, the tactile surfaces were laid until the entrances of all blocks for the visually impaired (Figure 9). Moreover, these surfaces were laid until the information desk for the disabled located inside the front block which is main entrance. The tactile pathways start from the point where pedestrian entrance starts. Also, they were connected to the exits of courtyards from the basement.

While the guiding marks were used on the walking axis of the tactile pathways, the warning surfaces were used for the areas such as turning point or entrance. The height of tactile surfaces was in the same elevation with the surrounding surface and it was yellow so as to be contrary to the environment. The width of warning surfaces was 60 cm and the width of guiding surfaces was 40 cm, a value which is supposed to be between 30 and 60 cm.

Fig. 9. Tactile pathways
