ALUMINIUM CUTTING SPECIFIC ISSUES

Iulian POPESCU, Cristina Ileana PASCU

University of Craiova, Romania

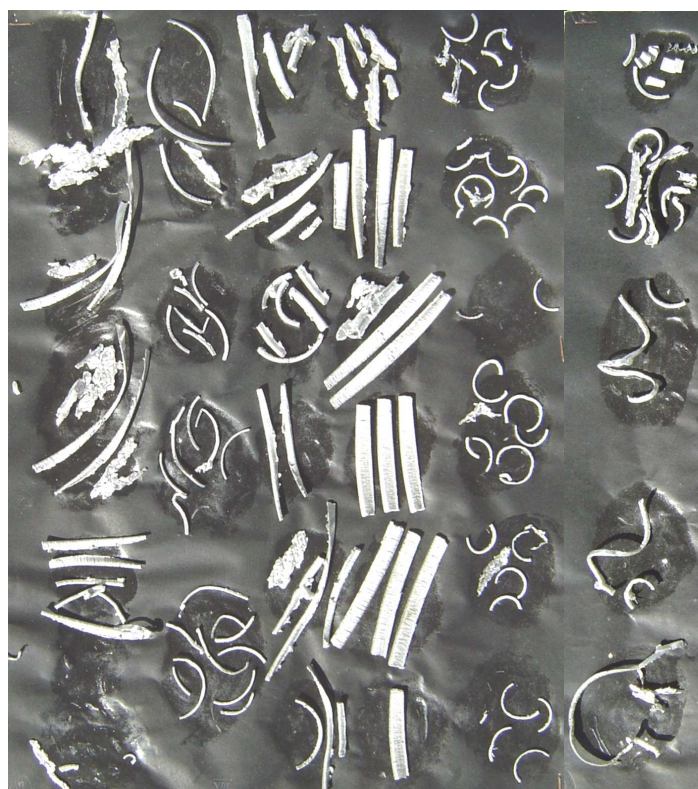
f/a_p 0.25/1 0.4/0.5 0.25/1.5 0.25/2 0.084/0.5 0.25/0.5

Figure 1. Resulted chips after cutting on different regimes

In figure 1 resulted chips after cutting on different regimes are shown.

From figure 1 can be noted an irregular shape of some of the chips and parts that were glued on the channel of front face.
